**CALSPAN ON-SITE AIR BAG DEPLOYMENT INVESTIGATION**

**CALSPAN CASE NO. 96-02**

**VEHICLE #1 - 1995 ISUZU TROOPER (AIR BAG EQUIPPED)**

**VEHICLE #2 - 1986 BMW 325 ES**

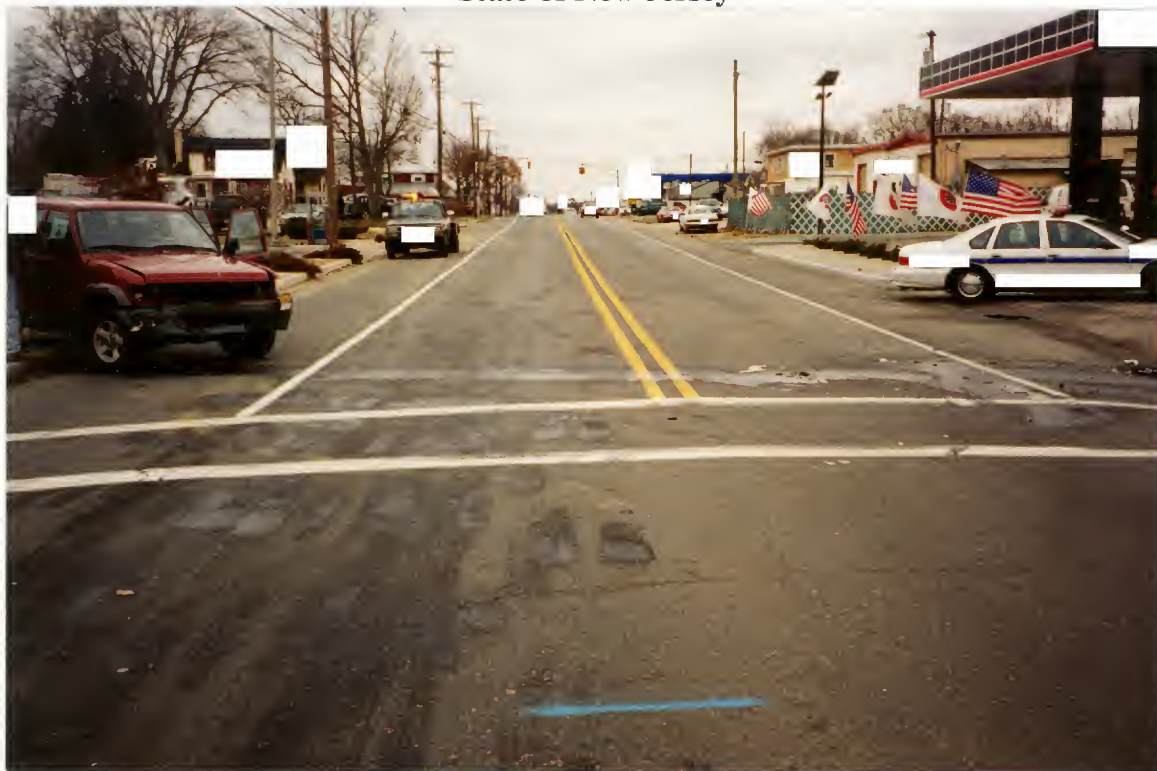
1. On-scene police photograph (looking east) showing the final rest position (FRP) of Vehicle #1 (1995 Izusu Trooper) and the point of impact (POI) with Vehicle #2 (1986 BMW 325 ES) noted by the fluid spill and debris near the right side of the photograph.

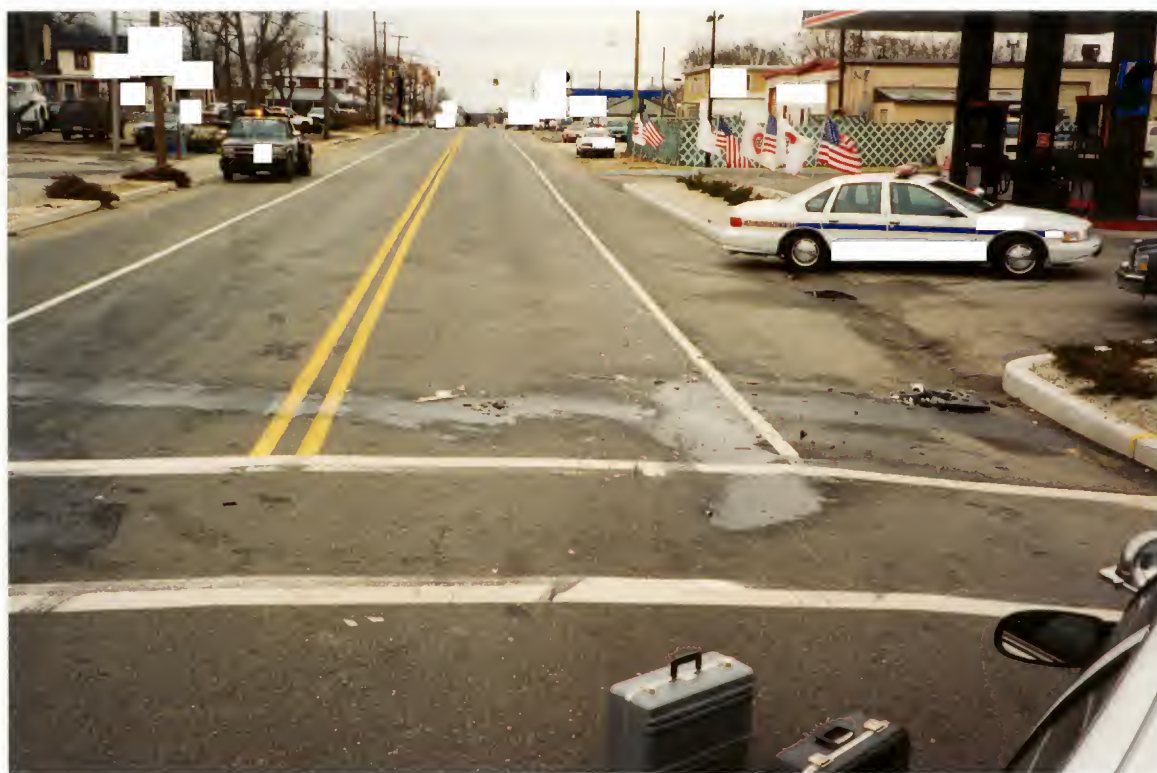
2. On-scene close-up view of the POI.

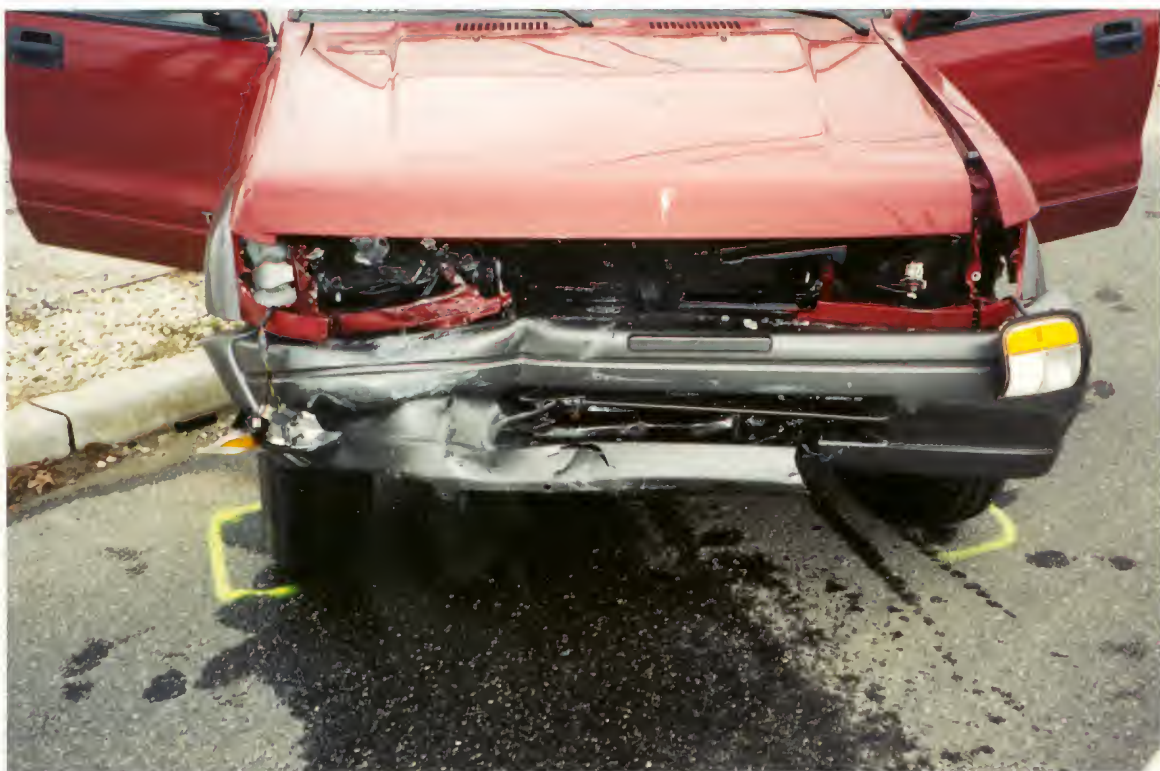
4. On-scene close-up view of impact damage to the front of Vehicle #1.

The frontal plane of the 1995 Isuzu Trooper struck the frontal plane of the 1986 BMW 325ES. Direct contact was noted across an area measuring 147.3 cm (58.0") which was located 69.9 cm (26.75") left of the vehicle centerline. Contact damage involved the front bumper, grille area, headlights, marker lights, directional signal lamps, the hood, and both fenders. The front bumper sustained a maximum rearward displacement of 38.6 cm (15.1") which was located 36.8 cm (14.5") right of the vehicle centerline. The maximum crush area resulted from contact with the left front bumper corner of Vehicle #2. The combined direct and induced damage length measured 161.3 cm (63.5") (refer to photographs #24 - #29 on pages A-12 through A-15). Crush values obtained along the bumper level are listed below:

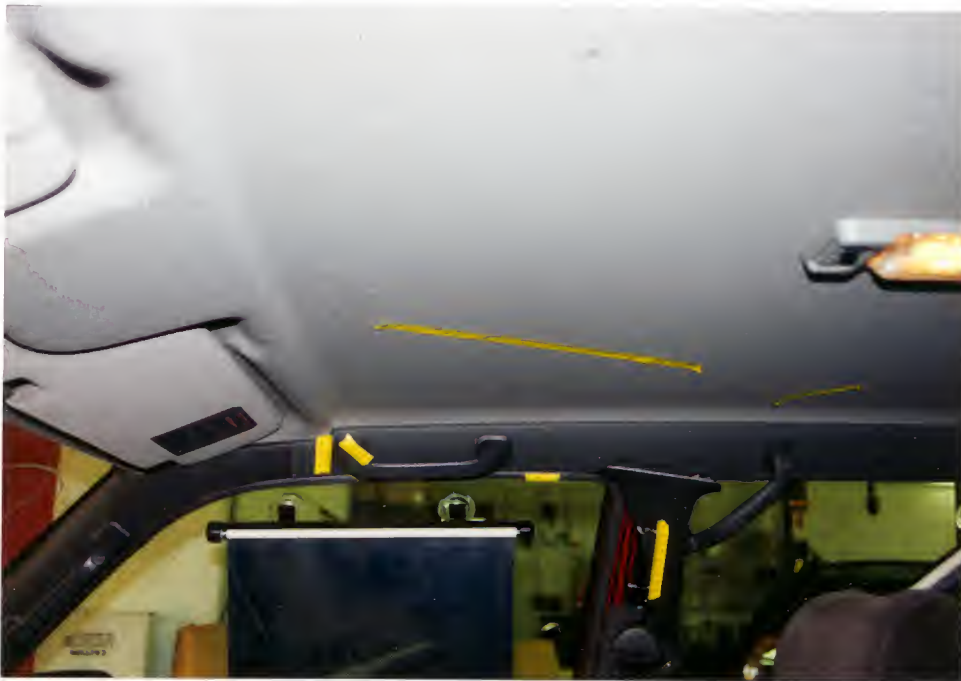
38. Closer view of the roof and right upper B-pillar highlighting a liner abrasion along the roof fabric and the fracture of the vinyl shroud over the pillar.

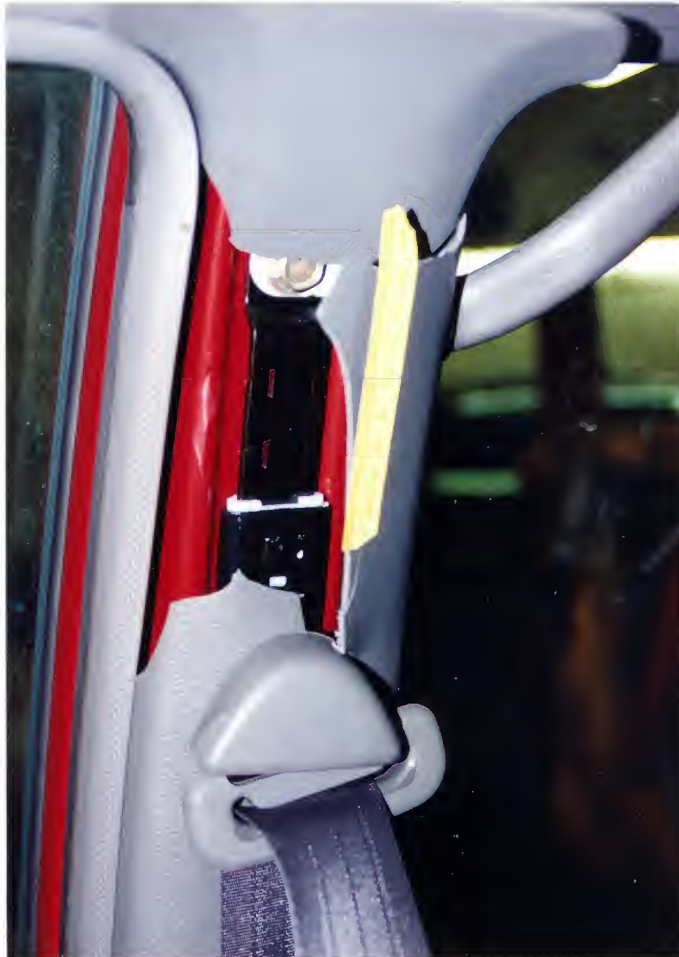
39. Close-up view of the fractured vinyl shroud over the right upper B-pillar.

Contact on the upper B-pillar resulted in the fragmentation of the plastic covering in an area measuring 17.8 cm (7.0") located 7.0 cm (2.75") below the right roof rail. Green fabric fibers consistent with the color of the safety seat covering was noted along the leading edge of the fracture site. The safety seat fabric along the left top surface on the in-board surface of the left head wing sustained a "L" shaped tear measuring 2.2 cm (0.9") vertically and 0.6 cm (0.25") laterally. This was consistent with the contact pattern on the upper B-pillar (refer to photograph #39 on page A-20).

The vinyl covering over the right upper B-pillar was cracked and fragment from contact with the child safety seat. Green fabric fibers located on the leading edge of the fracture site were consistent with the color of the child safety seat fabric covering.

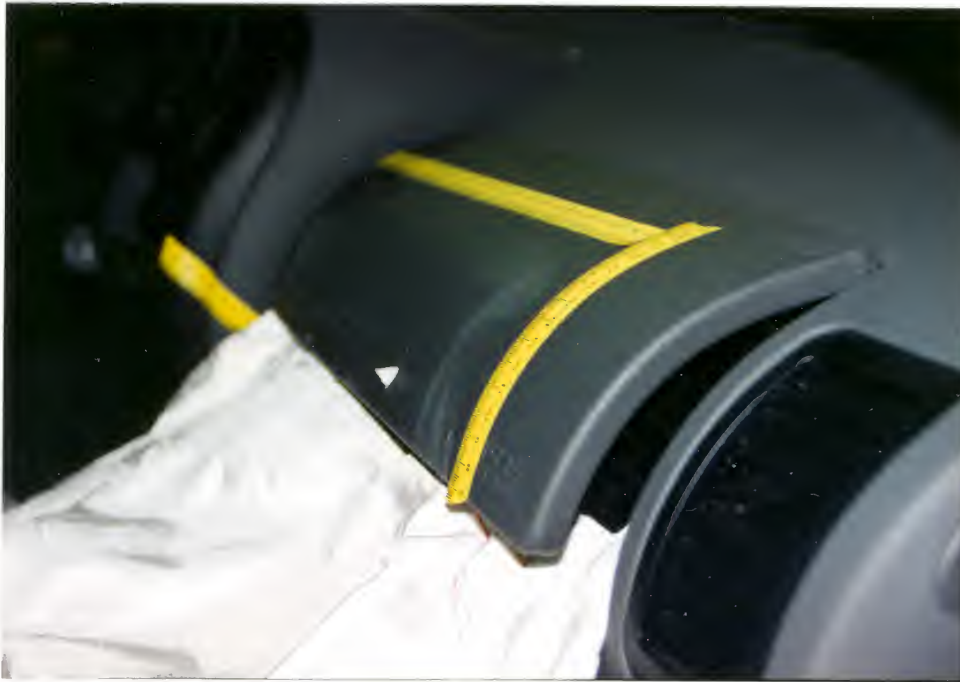
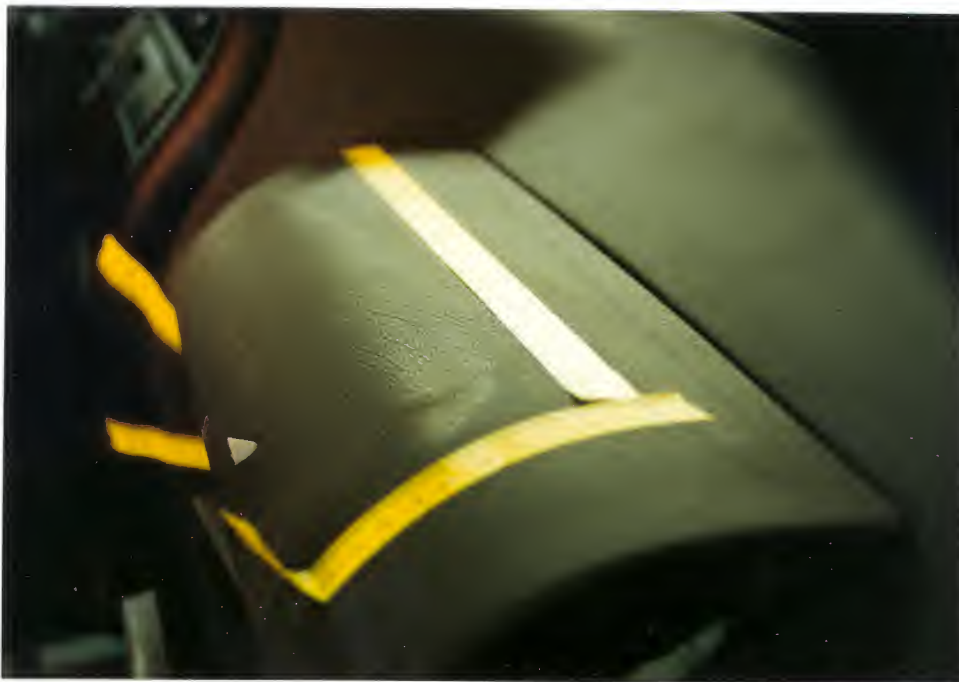
55, 56. Closer views of the right instrument panel highlighting contact evidence on the surface of the passenger side module cover.

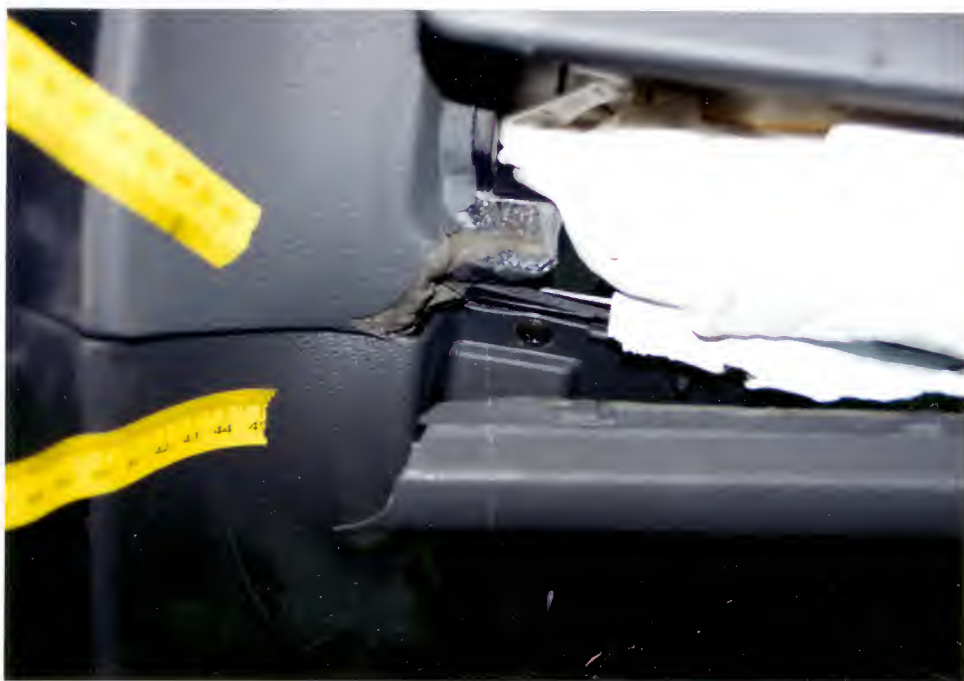
60. Close-up view of the broken portion of the right side instrument panel just below the passenger side air bag module.

A portion of the right instrument panel below the passenger side air bag module cover was separated at point located 20.3 cm (8.0") right of the vehicle centerline. This damage was the result of the expanding passenger side air bag during the SRS inflation sequence.

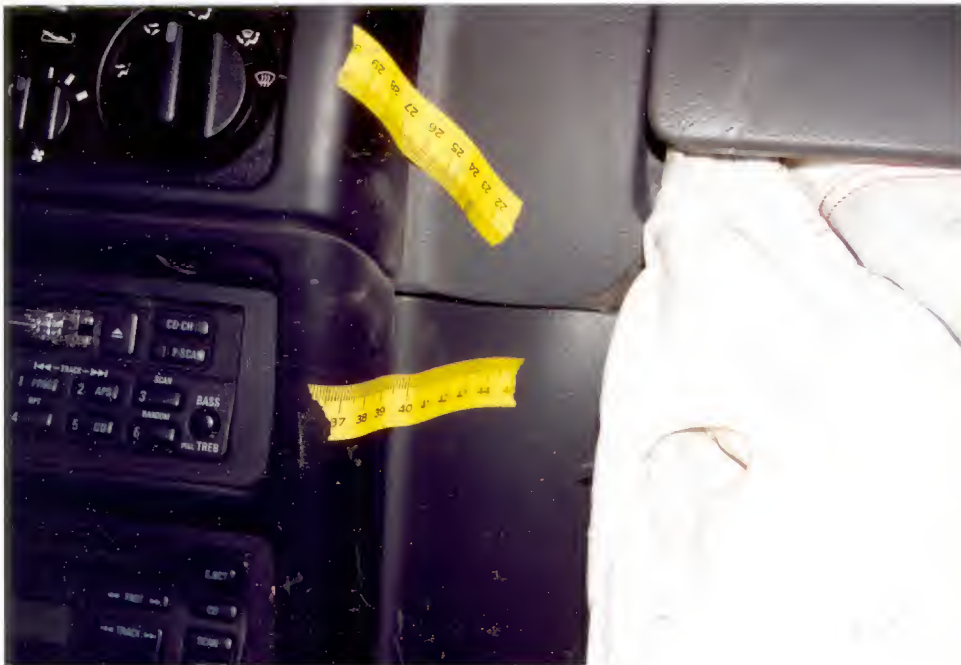
61. Close-up view of air bag generant residue located on the center instrument panel which was adjacent to the air bag vent port.

Two areas of passenger side air bag generant residue were noted on the right upper door surface and the right side of the center instrument panel accessory panel. The residue was gray in color and correlated with the location of the two passenger side air bag vent ports.

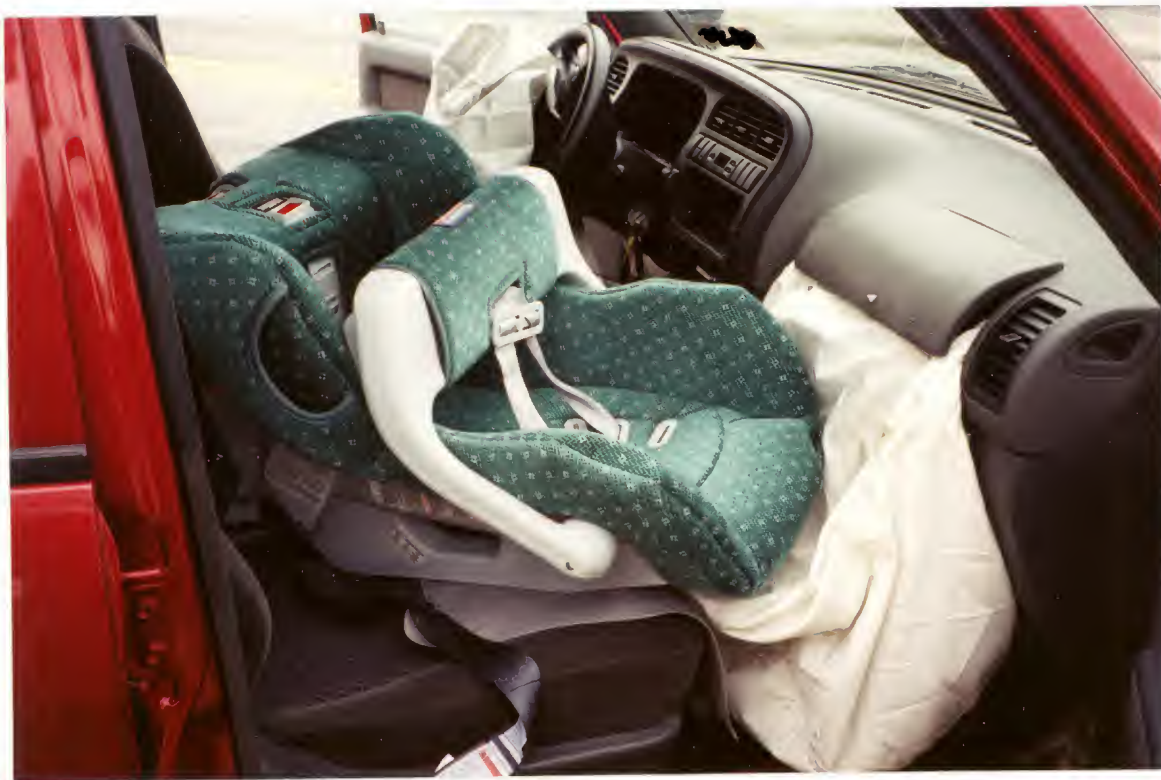
65. On-scene police photograph showing the position of the child safety seat upon arrival by the police.

On-scene photographs (refer to photographs #65-#67 on pages A-33, A-34) show the restraint belt latched and the safety seat laying on the seat cushion. It was reasoned that if the lap belt was used, then it had to be placed over the side surfaces of the safety seat on top of the green seat covering. Photographs #71 and #72 on page A-36 illustrate this technique and show the relative distance between the safety seat and the air bag module cover. In placing the seat in this position, care was taken to restrict the belt from rewinding into the retractor. Placement of the seat in this position appeared to place the seat at a distance that was inconsistent with the damage pattern noted on the rear surface of the seat and on the module cover (i.e., too far away). Additionally, there was no evidence of lap belt contact on the seat covering (e.g. fabric abrasion) or seat covering fibers embedded in the lap belt.

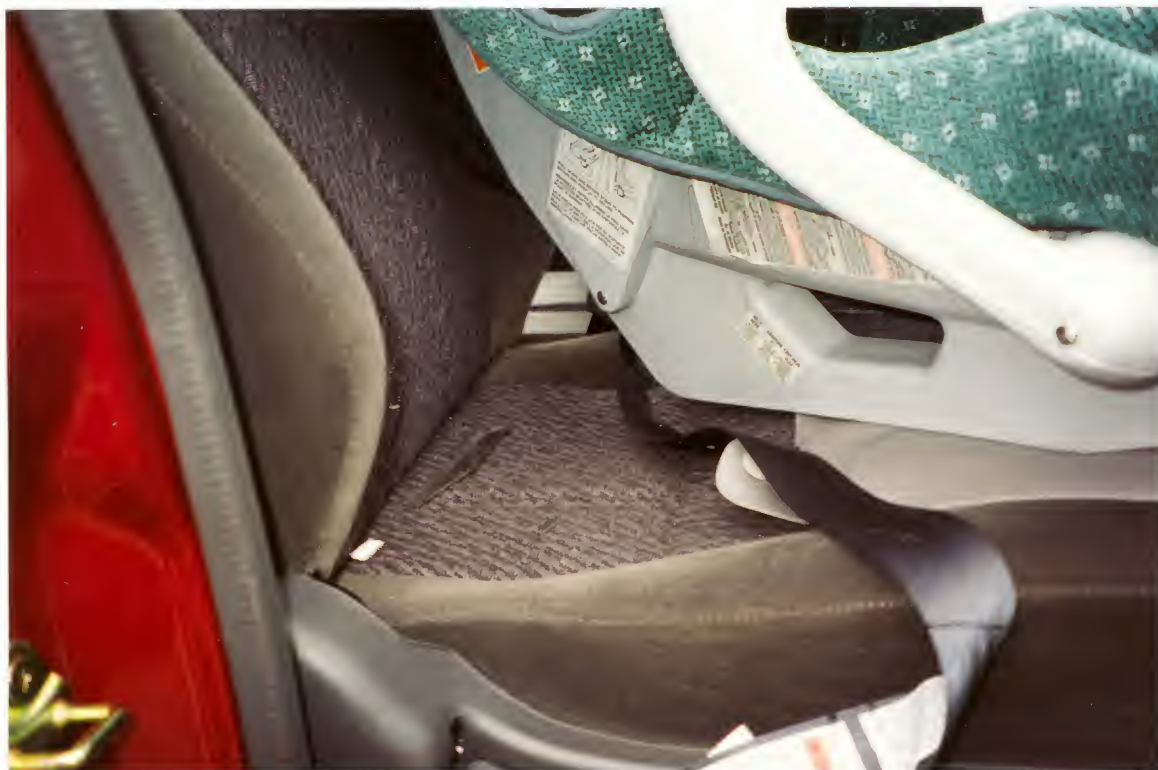
66. On-scene police photograph showing the lap portion of the manual three point lap and torso restraint belt.

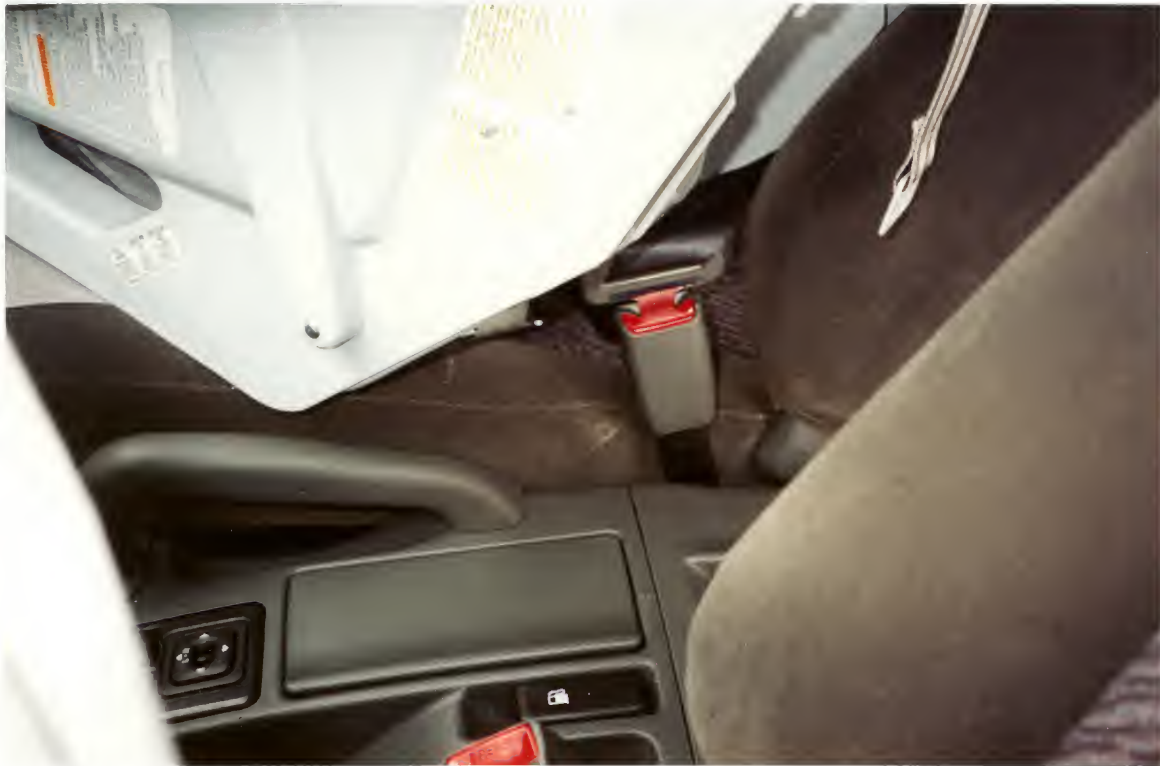
67. On-scene photograph showing the right front restraint belt latched upon arrival by the police department.

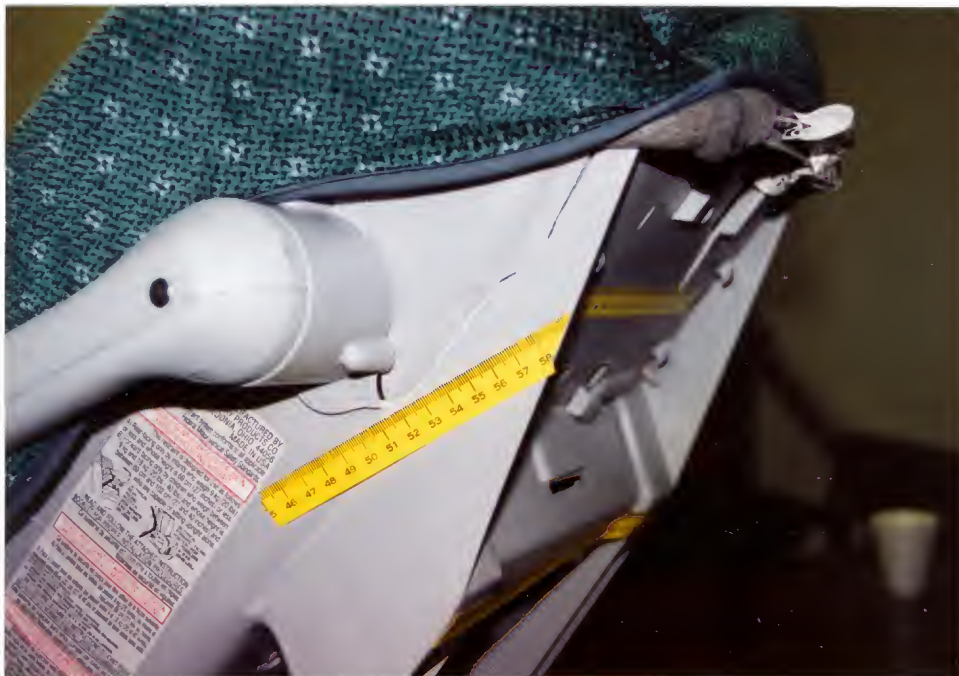
90. Close-up view of the fracture located adjacent to the shield support arm.

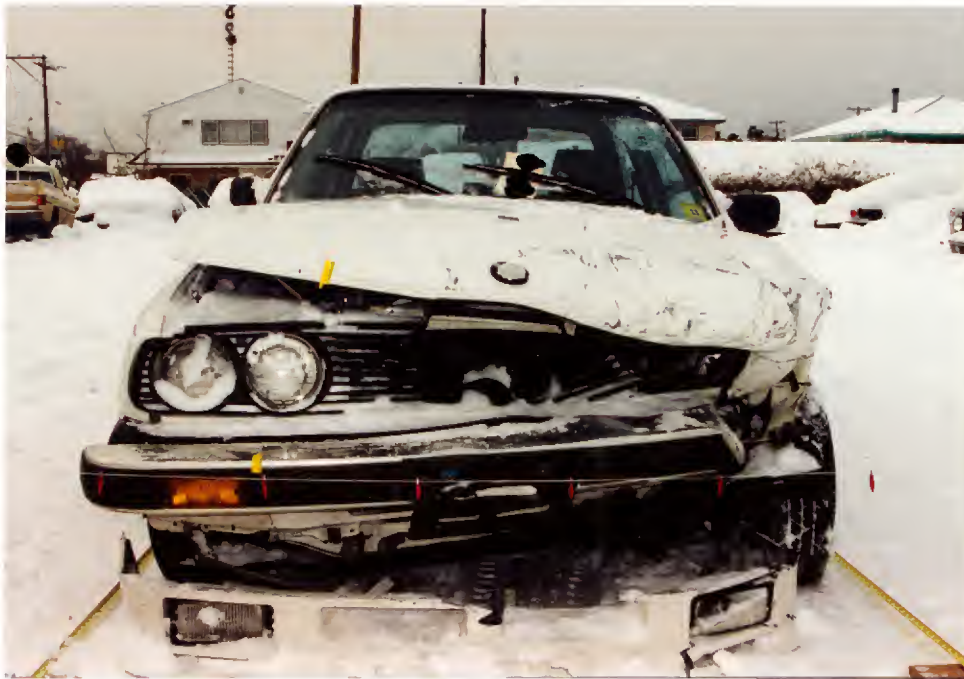
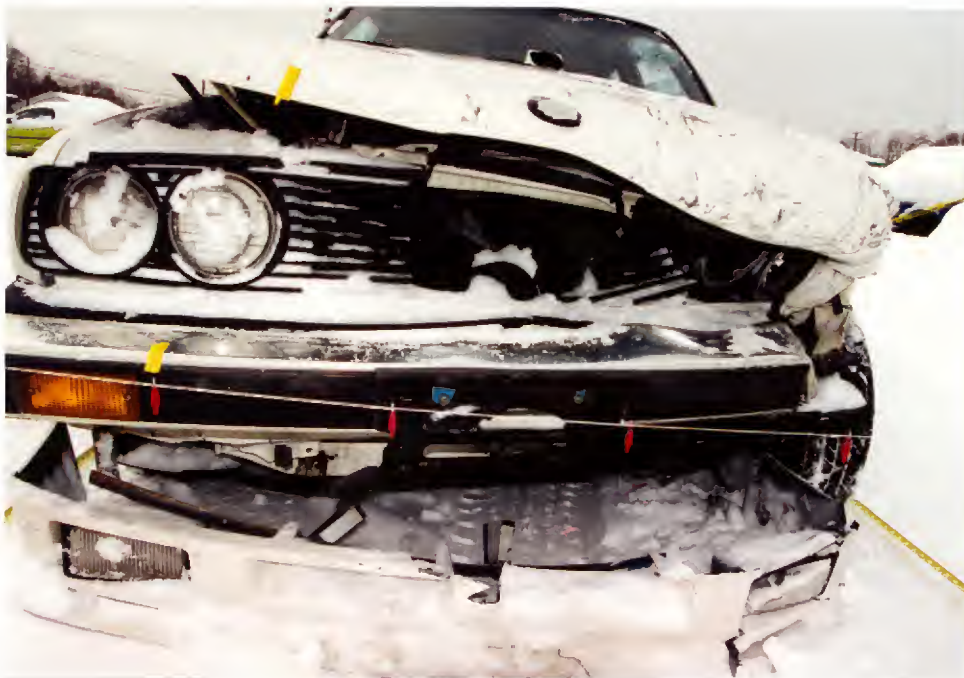
105, 106. Frontal views of the 1986 BMW 325 ES (Vehicle #2) showing impact damage.

Components damaged in the crash included the front bumper, the left headlight set, the hood, the lower valence panel, the grille area, the left fender, and the windshield.
